WATER QUALITY RESTORATION PLAN AND TOTAL MAXIMUM DAILY LOADS FOR THE SUN RIVER PLANNING AREA

DECEMBER, 2004

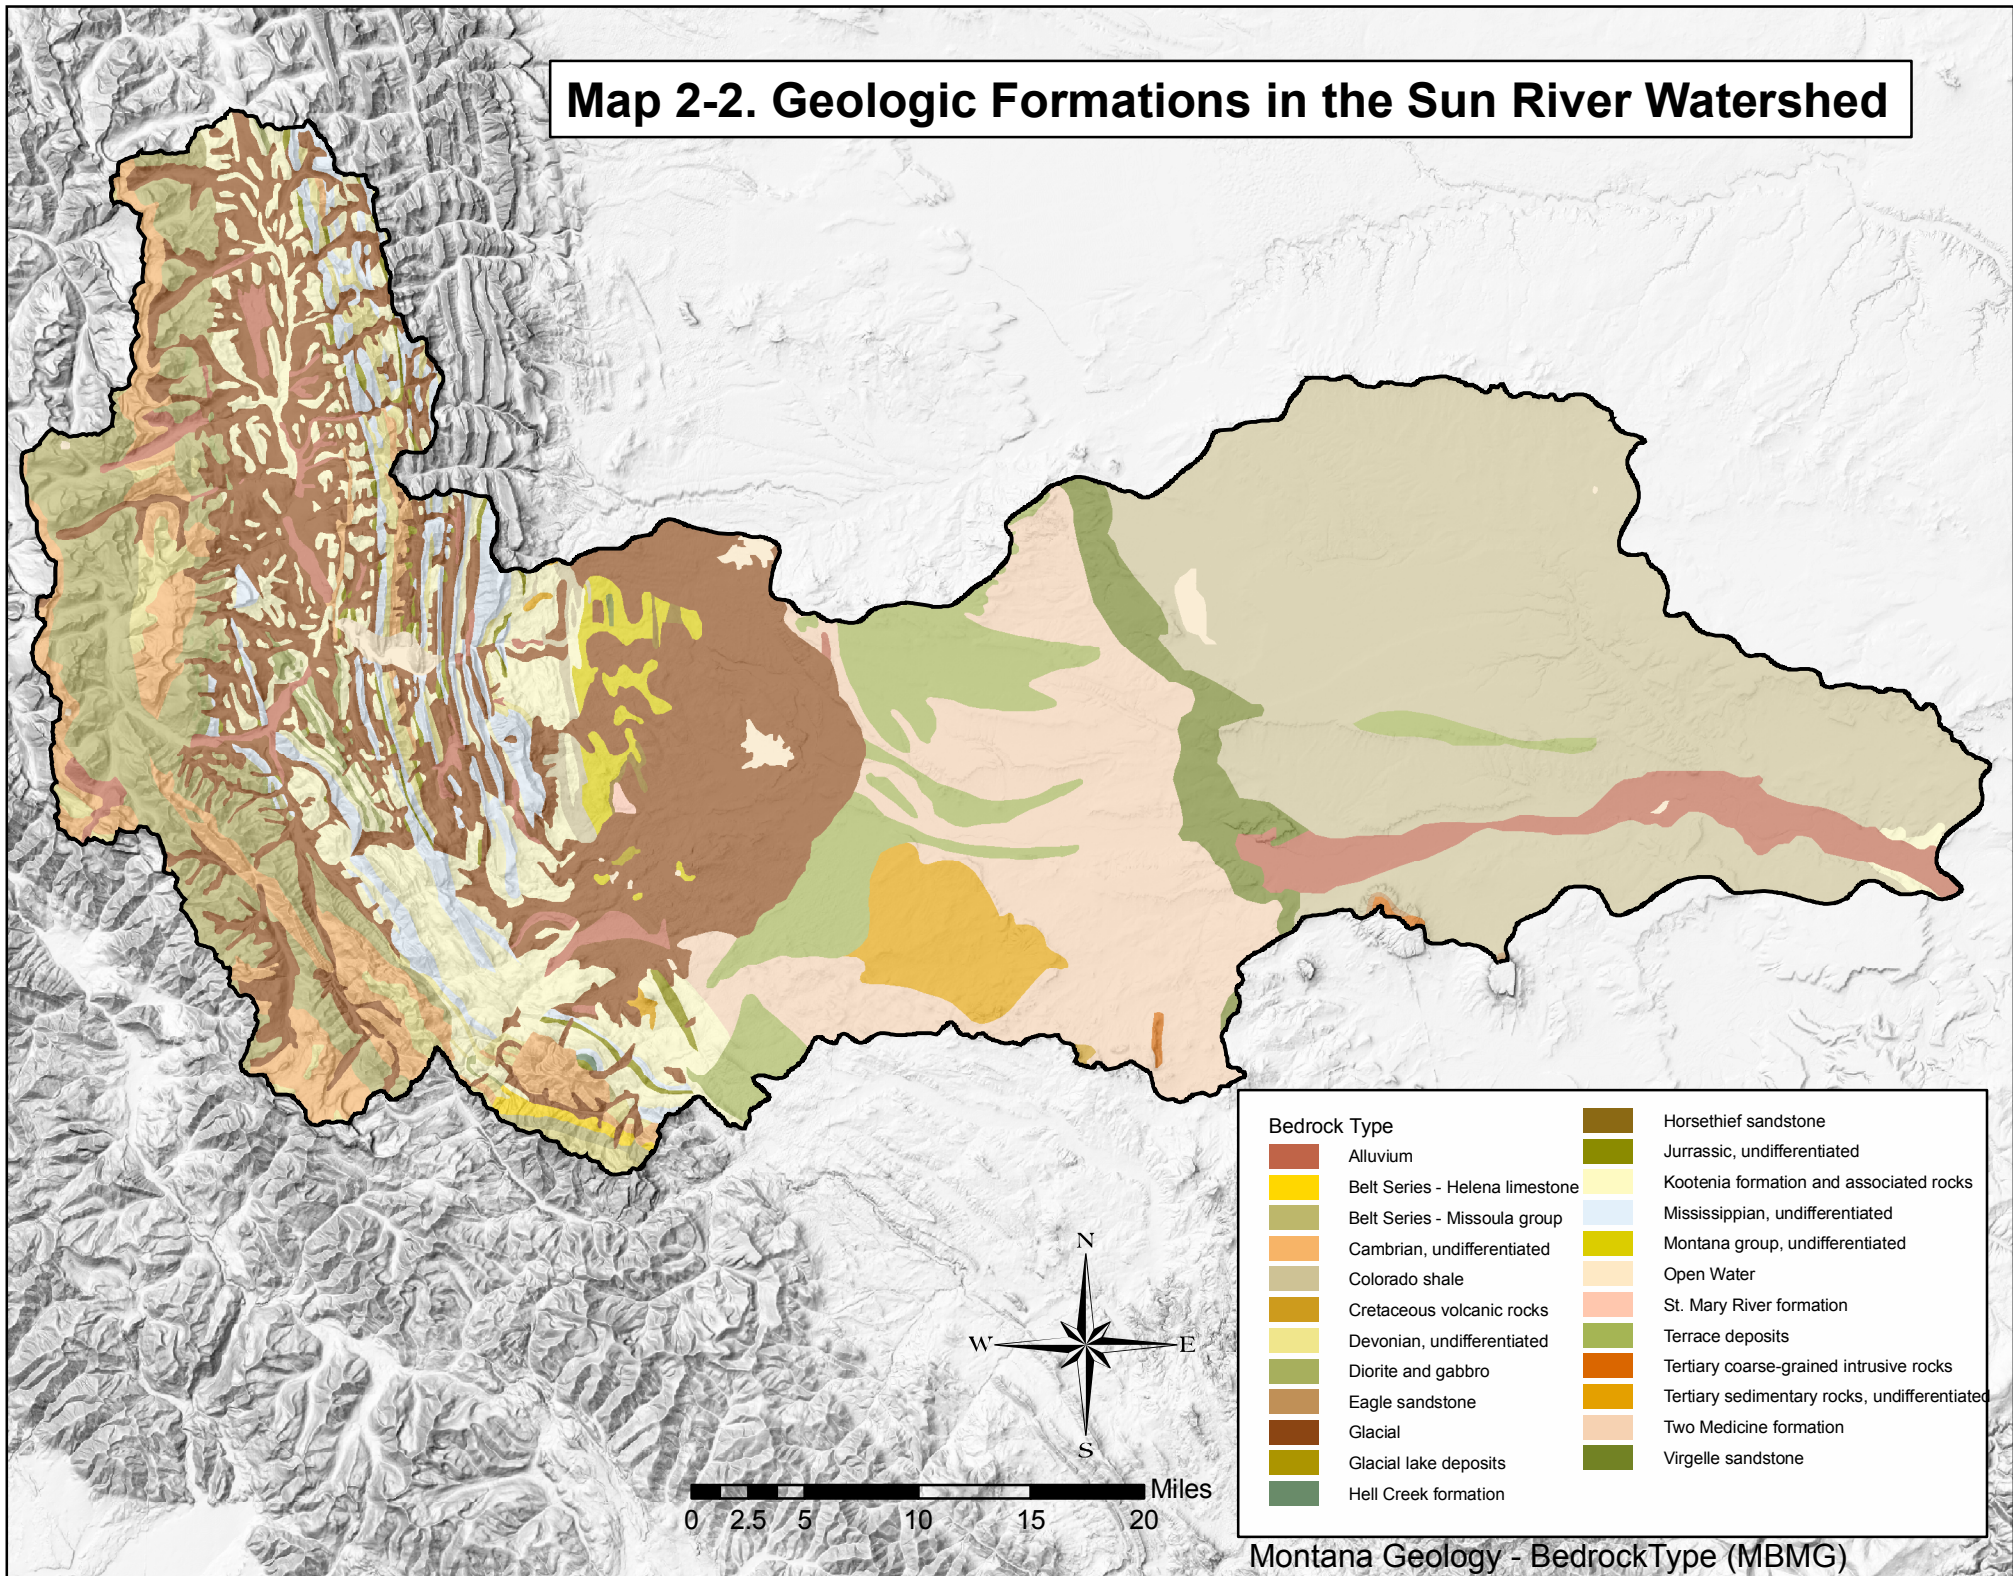
Map 2-2. Geologic Formations in the Sun River Watershed

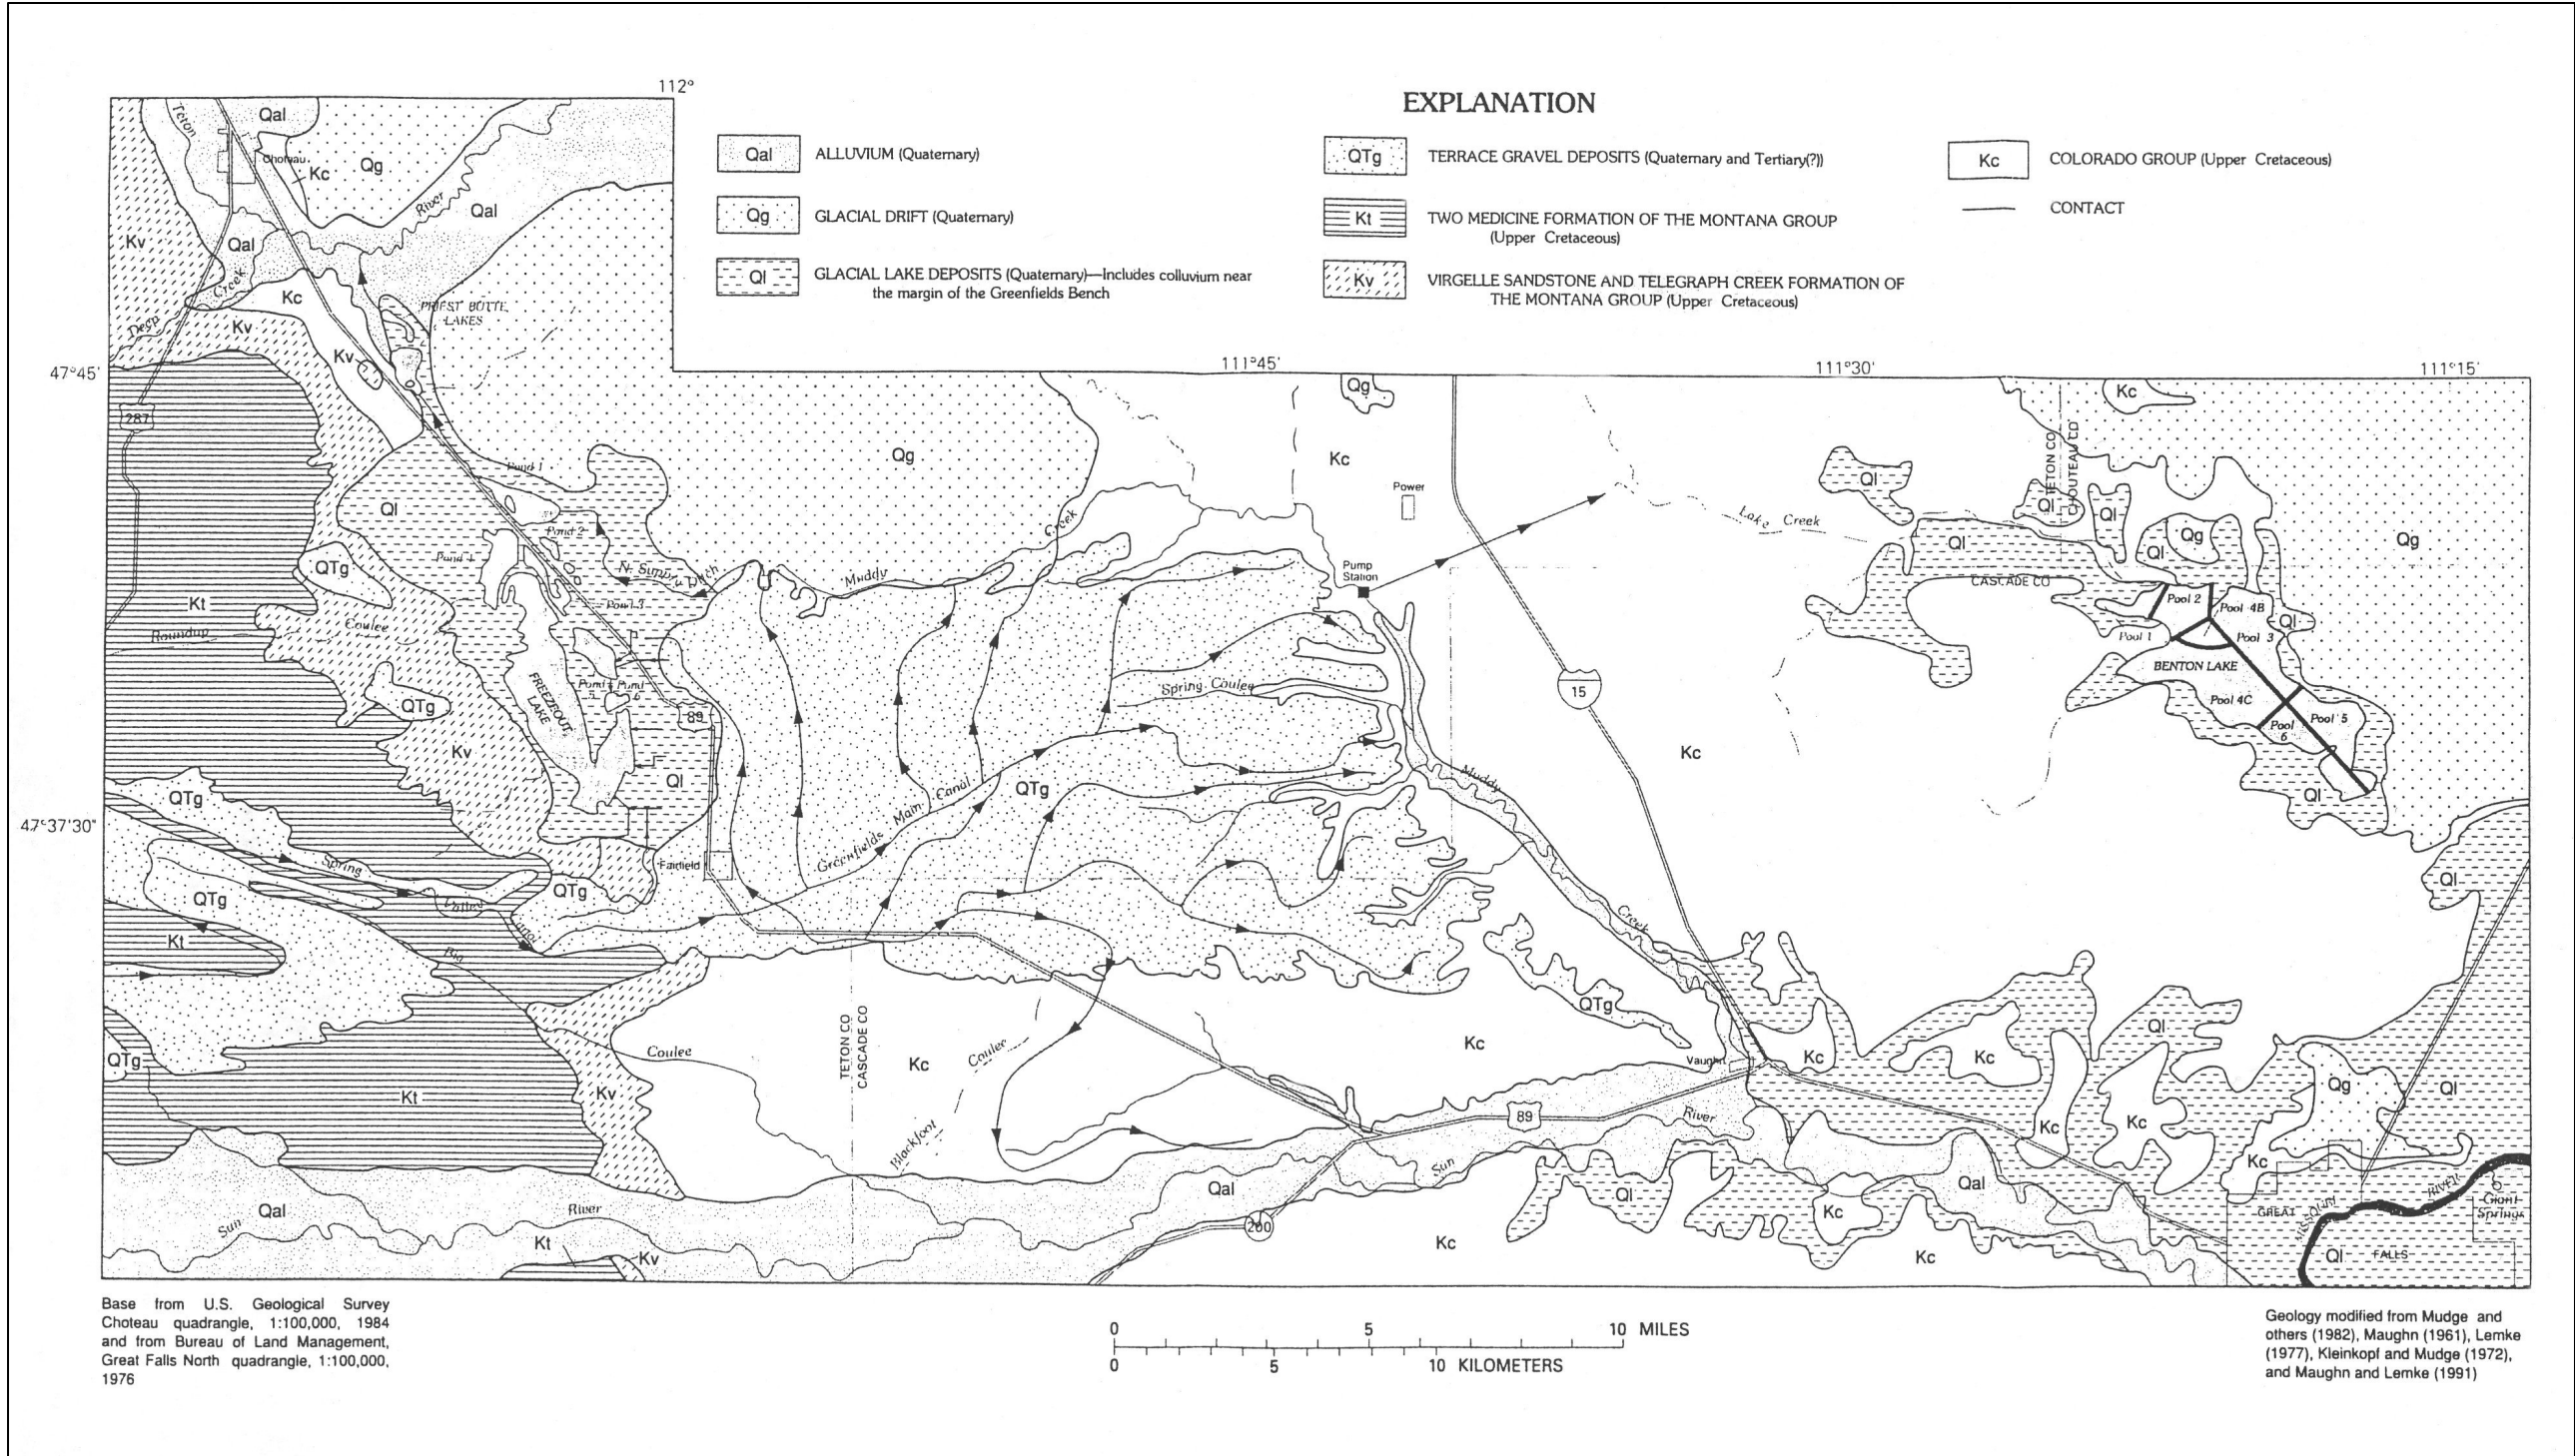
Map 6-1. Geology of the Greenfield Bench, Freezeout Lake and Muddy Creek areas. (from Nimick et al, 1996)

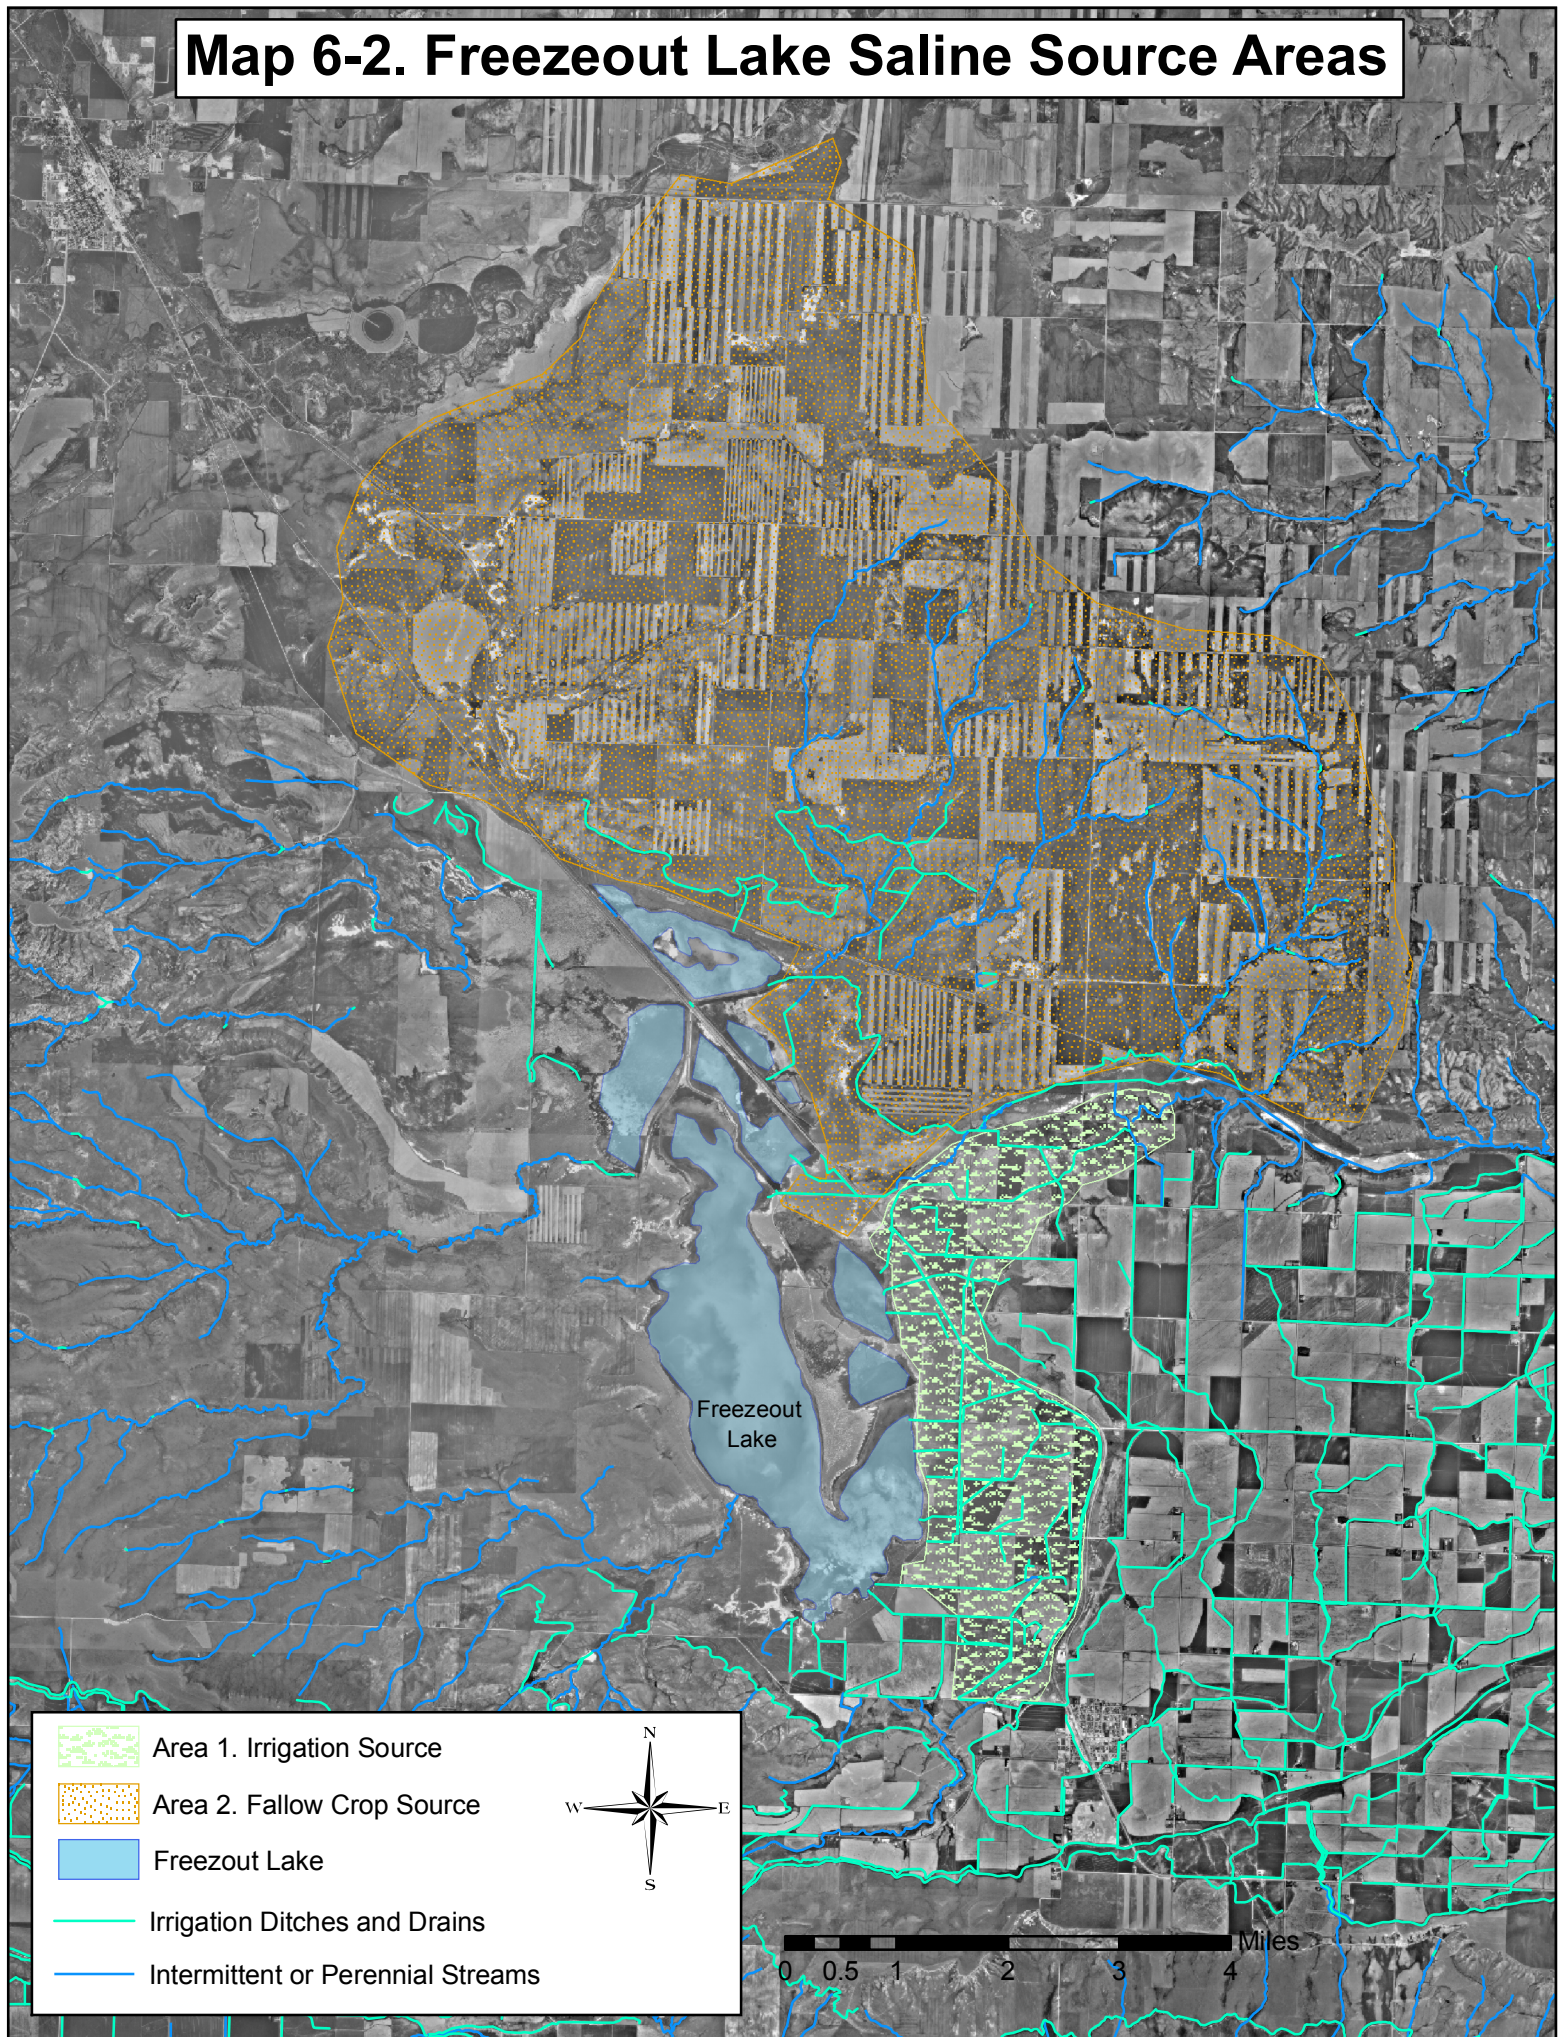
Map 6-2. Freezeout Lake Saline Source Areas

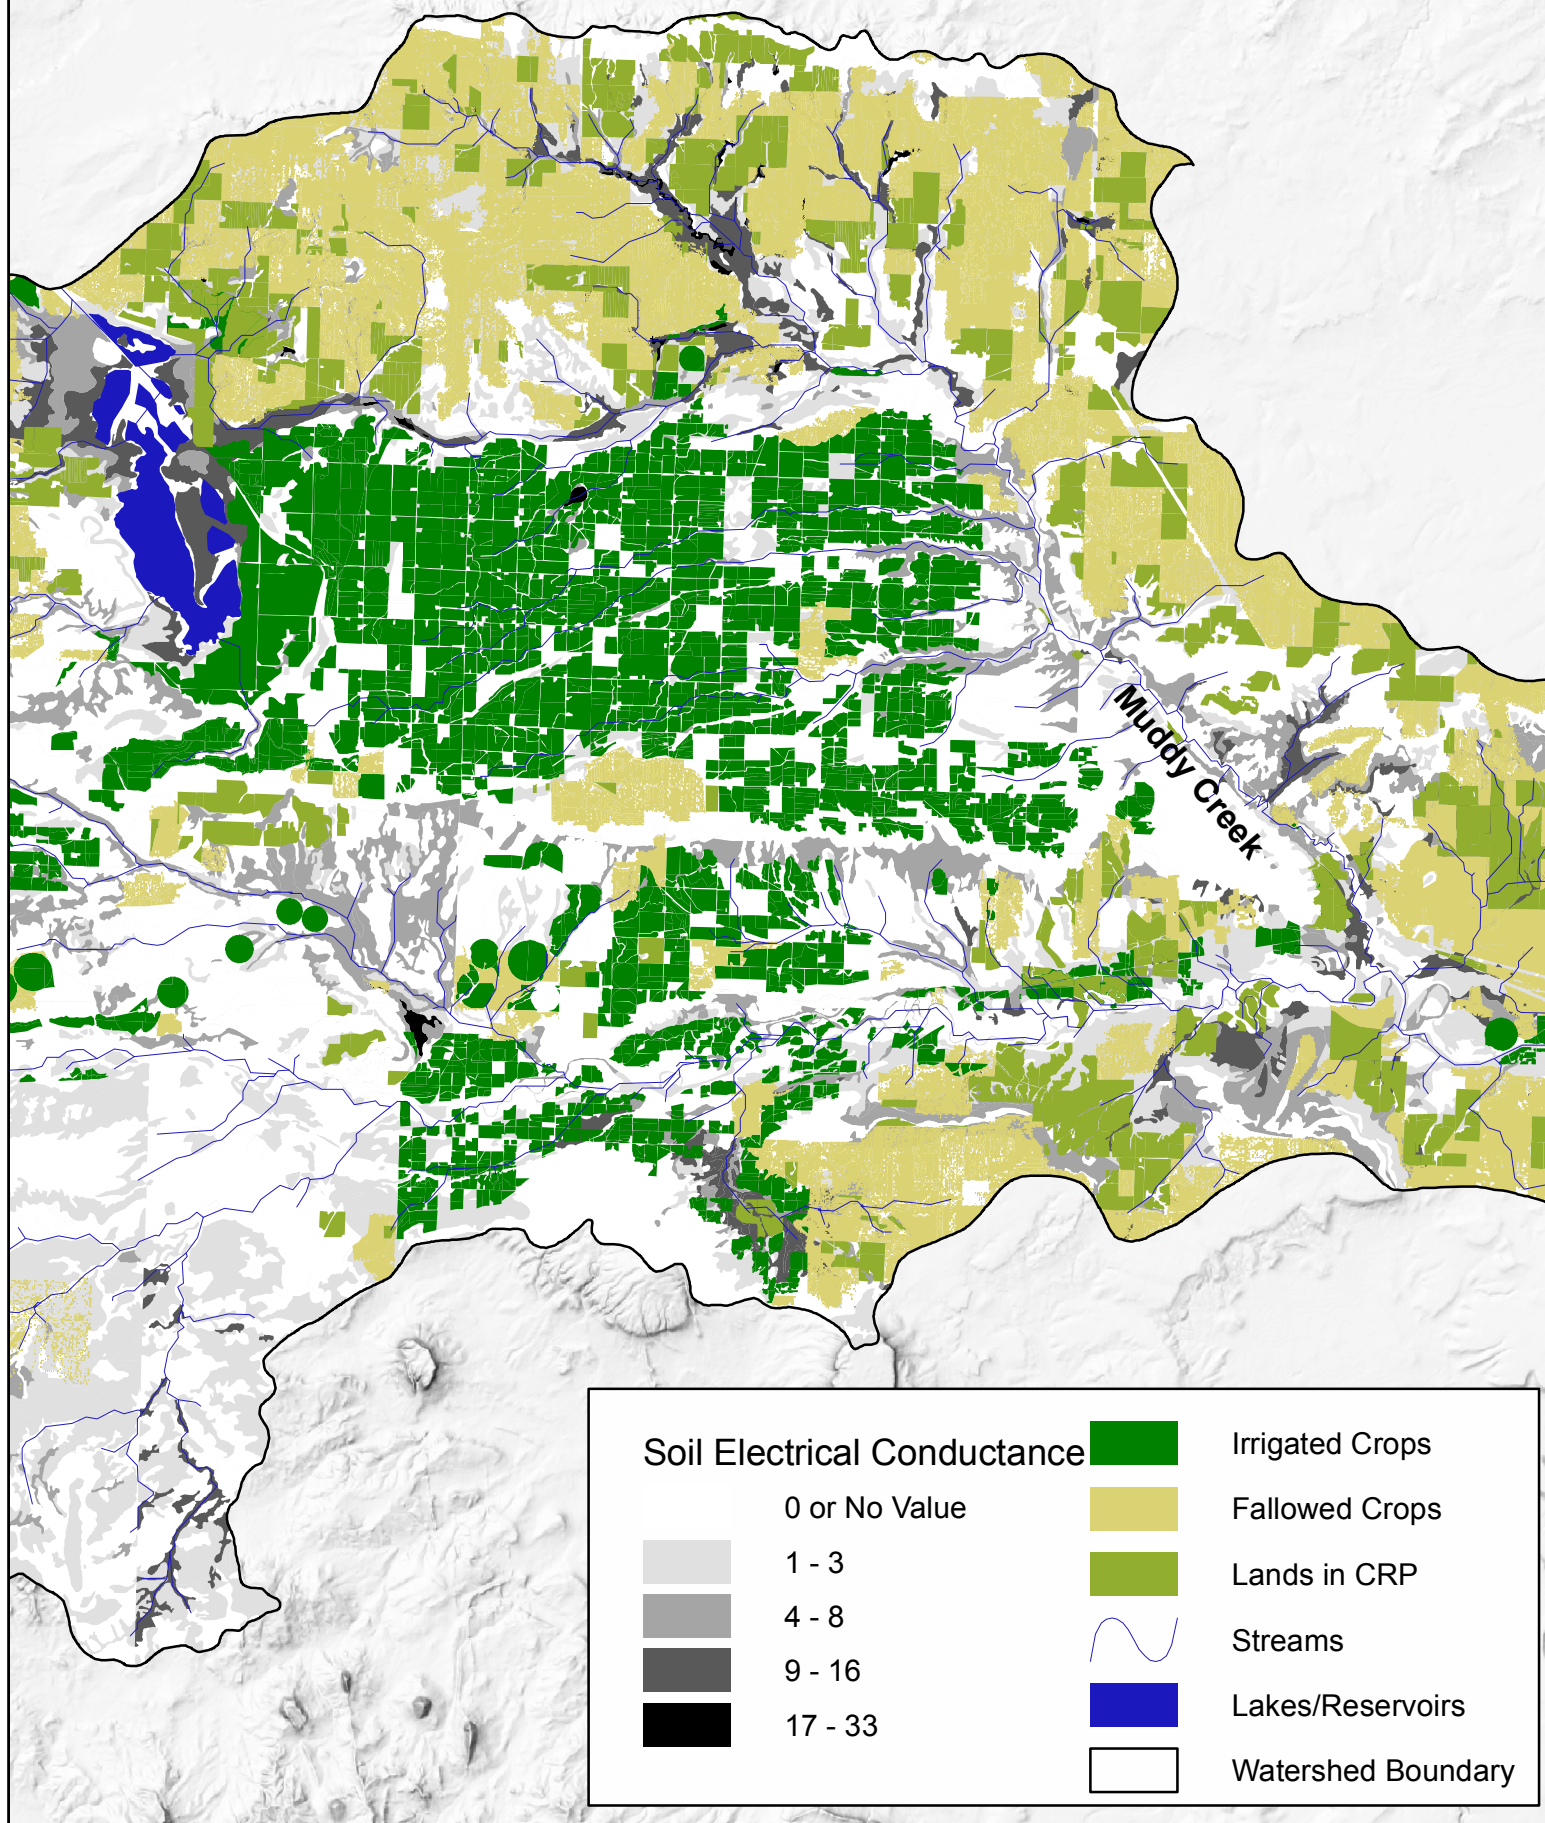
Map 6-3. Saline Sources and Soil Electrical Conductance in Muddy Creek and Freezout Lake Watersheds
